Devil's Slide/Hwy 1 Storm Repair

Daily Updates from Bijan Sartipi

Daily Update
June 17 and 18

Devil's Slide (post mile 39.14)

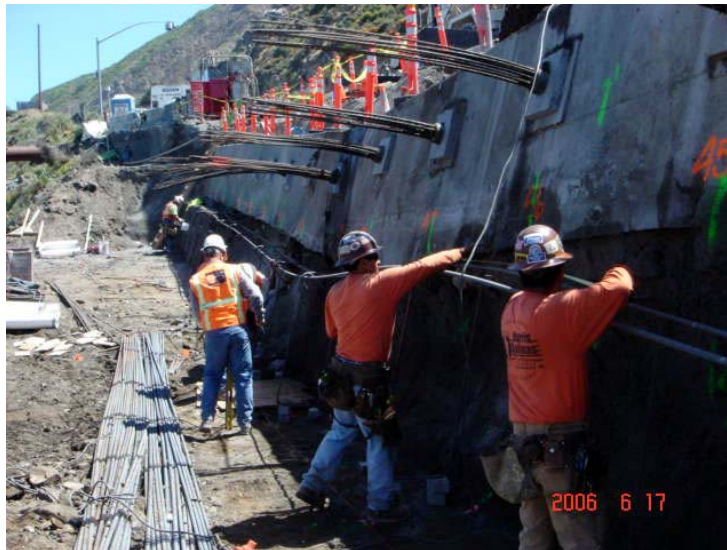
- Whaler (bracing) wall construction:
Whaler wall 'A' (upper level ocean side) – complete.
Whaler wall 'B' (lower level ocean side) – forming the wall with rebar.

Reinforcing steel being installed for wall B

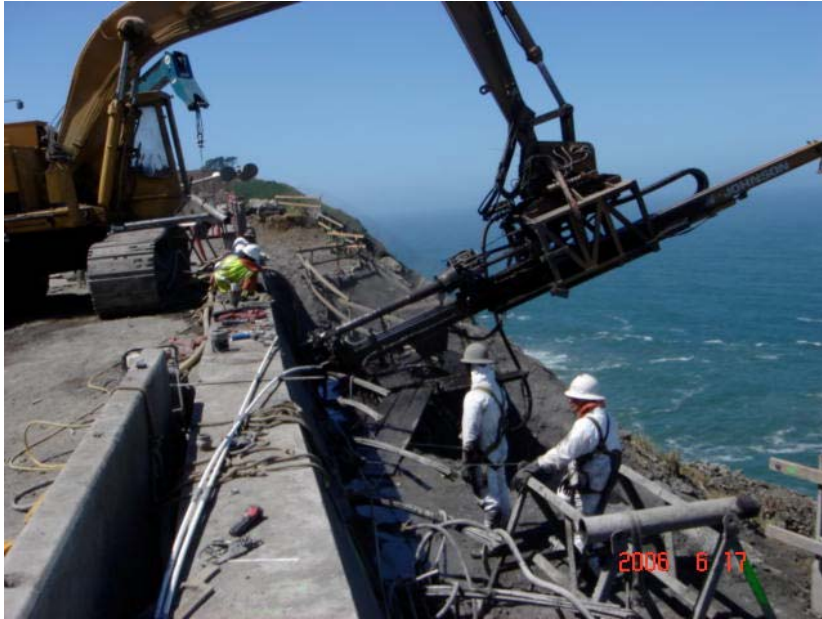
- Drilling and tie back installation:
Whaler wall 'A' – drilling continued using the reach over rig.
Stressing tie back cables also took place.

Drilling at wall A using the reach over rig.

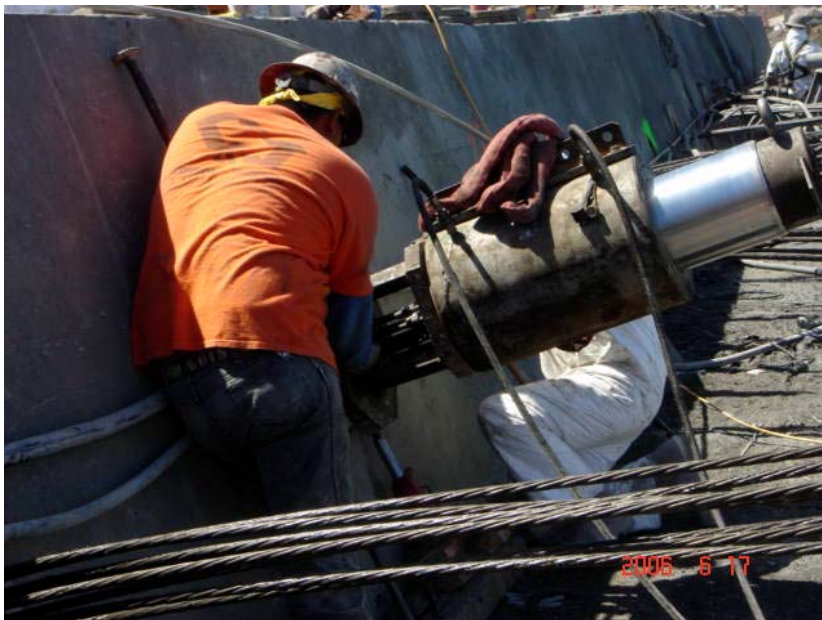
Stressing cables – wall A
